# Walkability Safety Assessment of City Road Corridors

## Lusaka, Zambia

May 2024

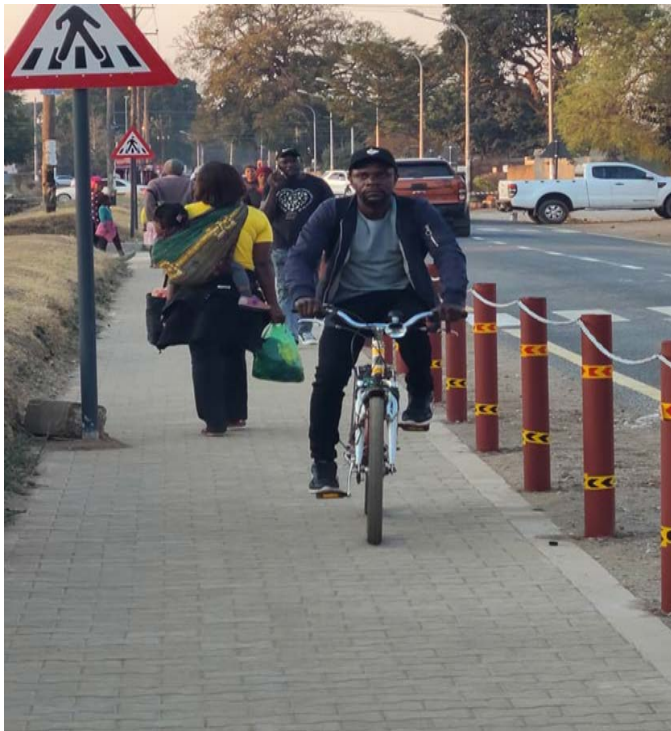
*Figure 1. Pedestrian sidewalks implemented along Lusaka's primary school.*

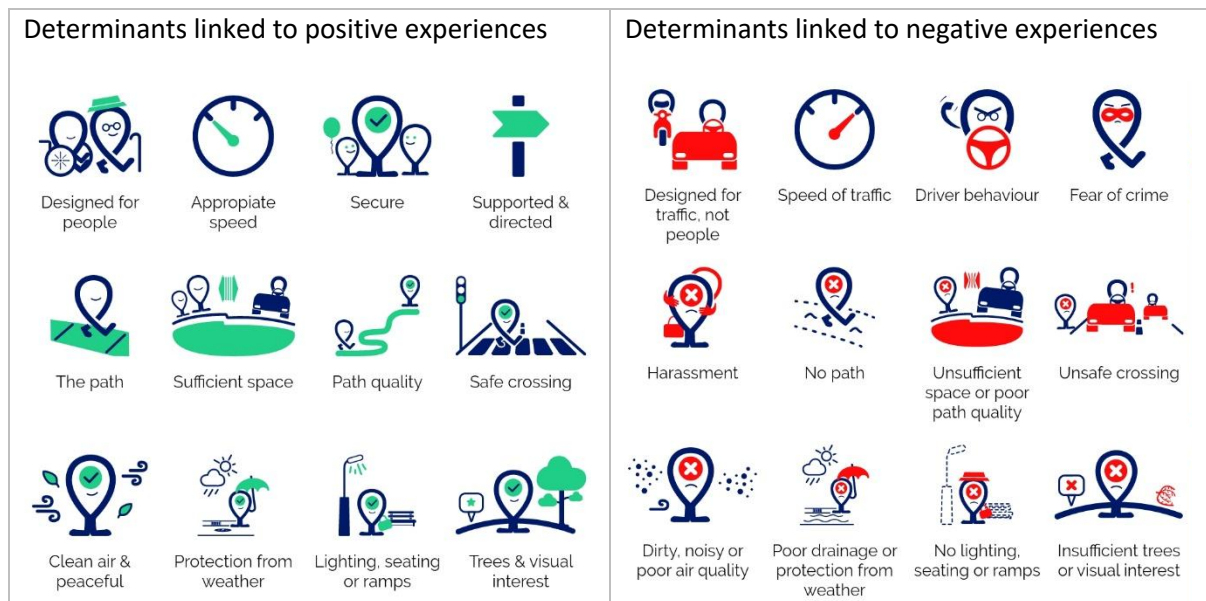
Figure 3. Pre-defined environmental determinants of perceived walkability.

Furthermore, the app allows for the segmentation of observations by age, gender, and personal abilities, facilitating a better understanding of the unique needs and barriers faced by different populations. This inclusive approach assists policymakers in designing and managing interventions in the public space that cater to diverse groups. The app's systematic data collection, analysis, and presentation methods, tailored to the specific population and location, make it a valuable tool for walkability case studies and reassessing the impact of walkability interventions. There are 12 categories linked to positive experiences and 12 for negative experiences and concerns. Refer to Figure X.

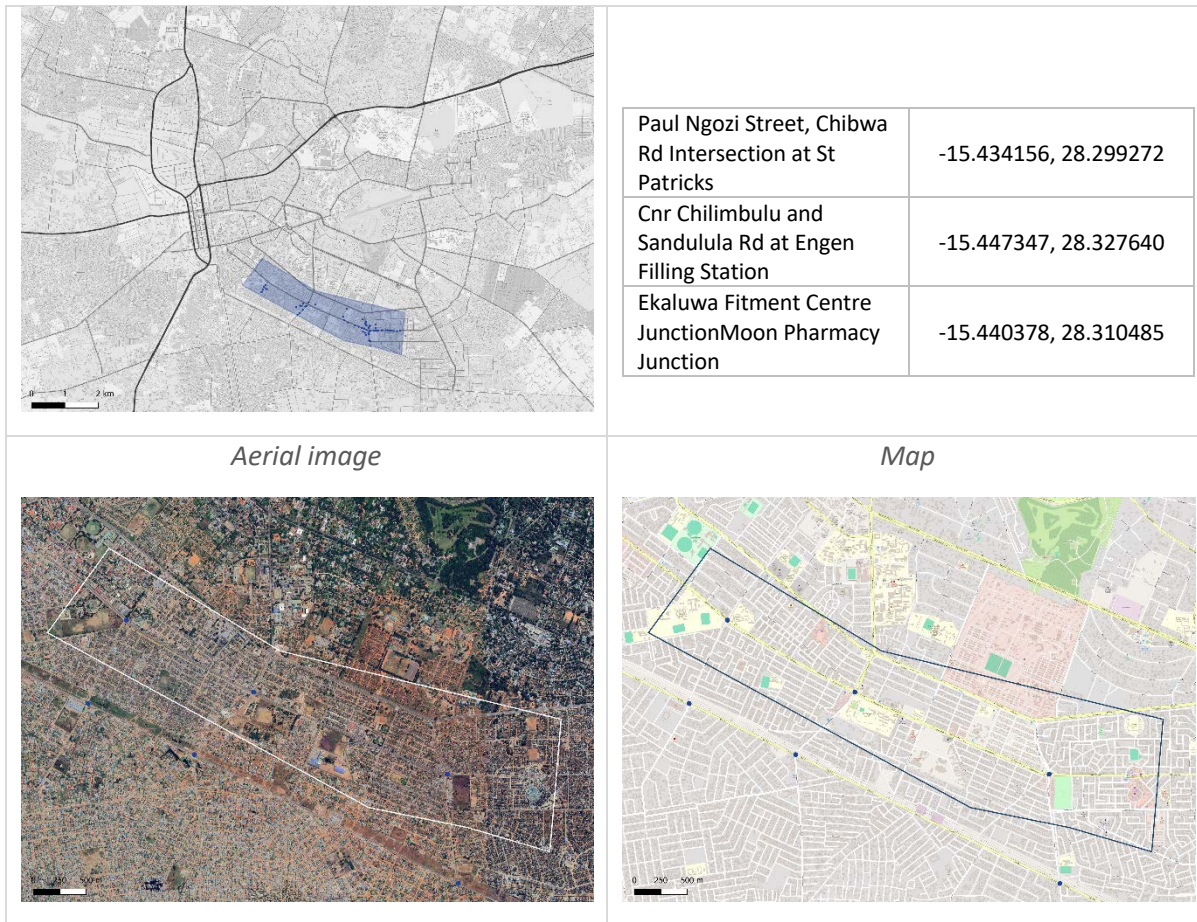
Figure 11. Chilimbulu Road.

Chilimbulu is a notable street in Lusaka, featuring residential properties, including standalone houses and flats. It is characterised by its tarred surface, indicating a well-maintained road suitable for regular vehicular and pedestrian traffic. The presence of educational institutions like Kamwala Secondary School and St Patrick Girls School along Chilimbulu Road serves as a significant route for locals, and businesses, providing access to essential services and amenities.

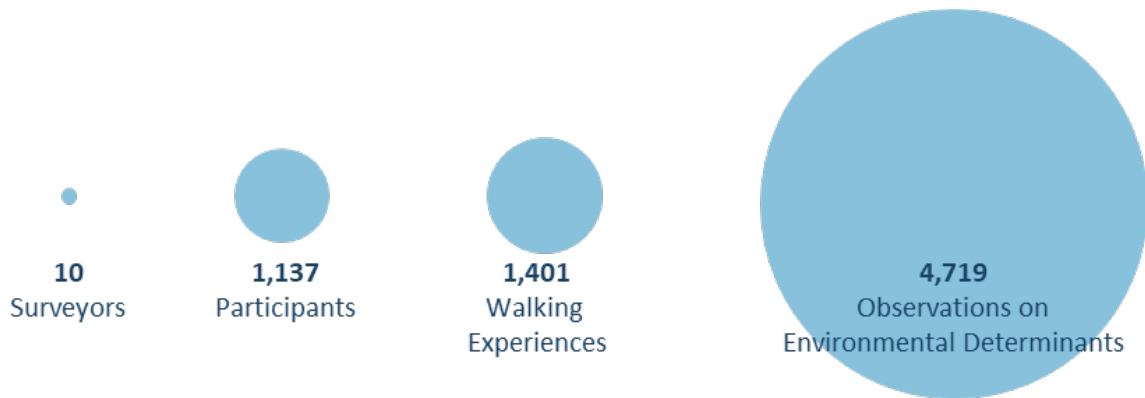
Figure 16. Number of surveyors trained, participants engaged, walking experiences shared and observations taken.

From the 19<sup>th</sup> to the 23<sup>rd</sup> of December in 2023 (5 days), 10 trained surveyors interviewed 1,137 participants in ten study areas in Lusaka. The 1,137 participants shared a total of 1,401 walking experiences, linked to a total of 4,719 environmental determinants.

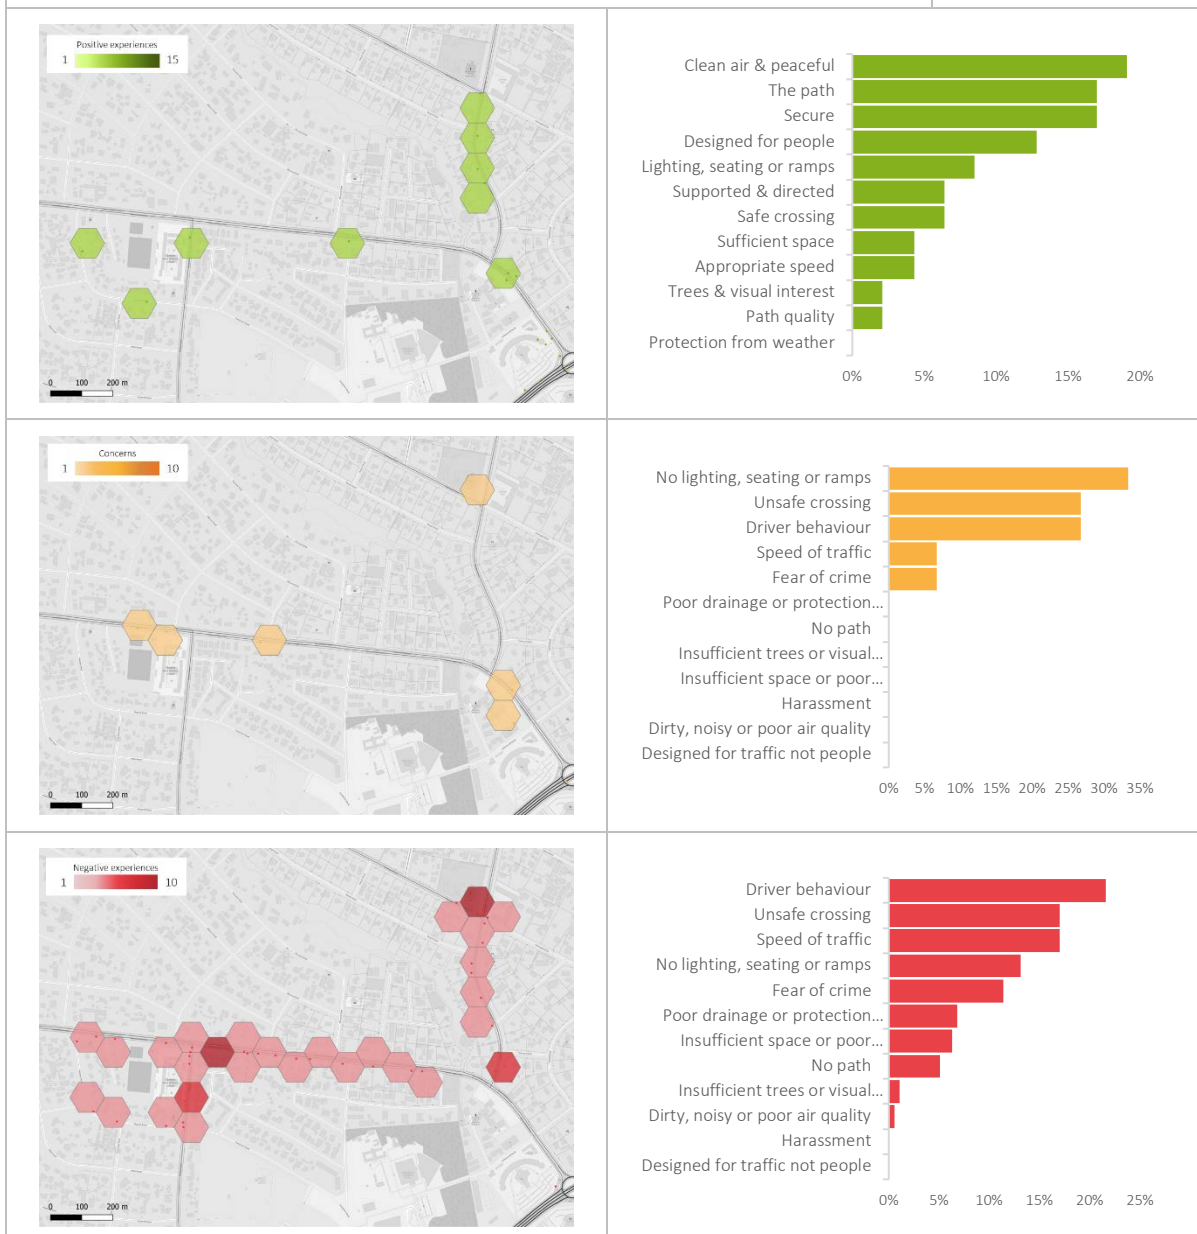
Figure 24. Main walkability outcomes in Katima Mulilo Road.

In Katima Mulilo Rd., most of the walking experiences were negative (75.4%) and related to 'Driver behaviour' (16%), 'Speed of traffic' (12.6%) and 'Unsafe crossing' (12.6%). Followed by positive experiences (15.9%) related to 'Clean air and peaceful' (3.8%), 'Secure' (3.4%) and 'Designed for people' (3.4%). And finally, concerns (8.7%), related to 'No lighting, seating or ramps' (2.1%), 'Driver behaviour' (1.7%) and 'Unsafe crossing' (1.7%).

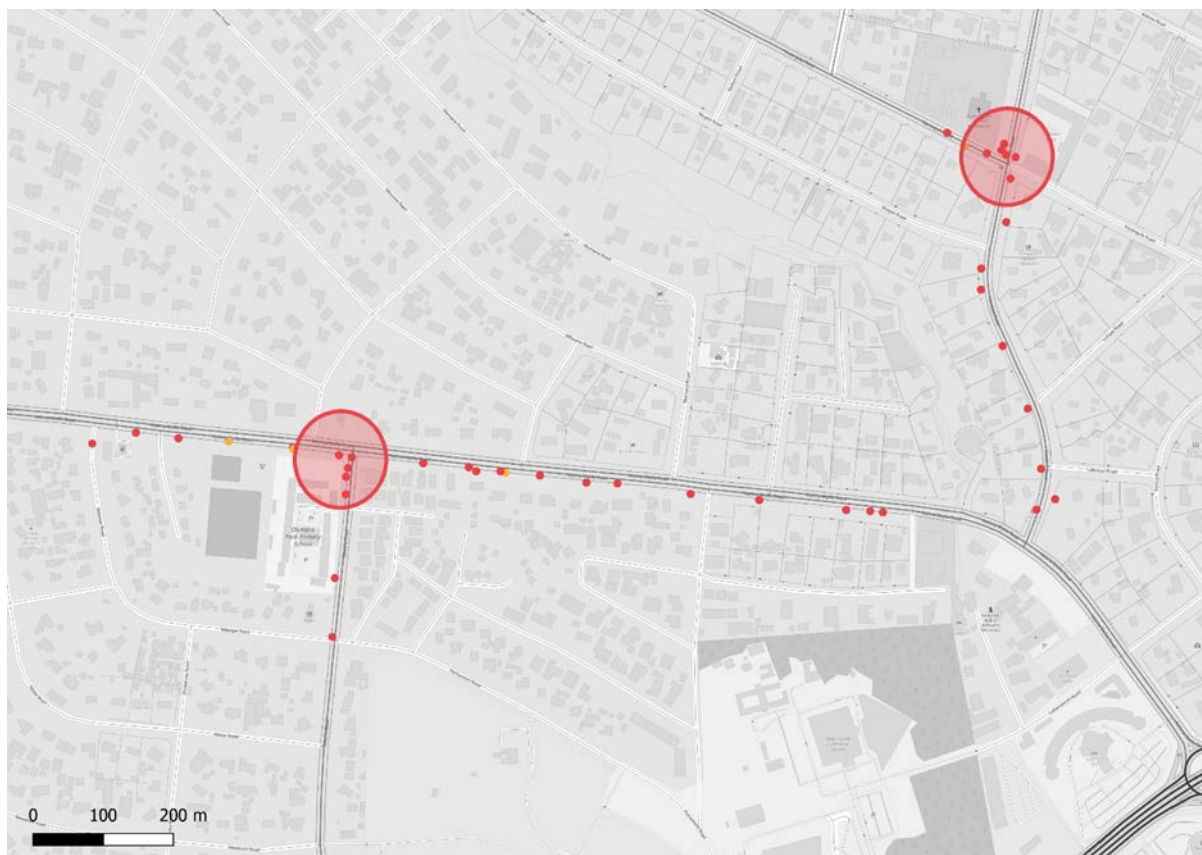
Figure 26. Areas for proposed intervention in Katima Mulilo Rd.

The most frequent determinants related to negative experiences and concerns in Katima Mulilo Rd. were related to ‘Speed of traffic’, ‘Driver behaviour’ and ‘Unsafe crossing’. This is a map that shows where these experiences were collected and highlights two areas with a high concentration of these negative experiences, coinciding with two road intersections: Kasangula Rd. with Zambezi Rd. and Katima Mulilo Rd. with Kwacha Rd.

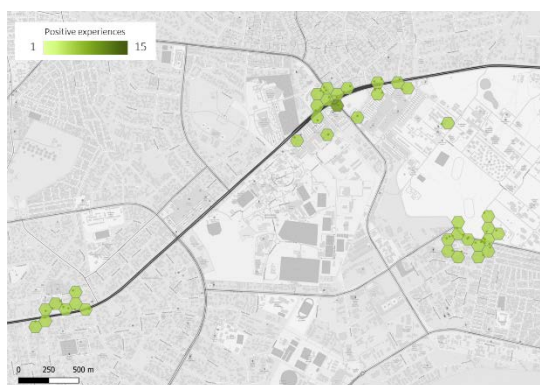
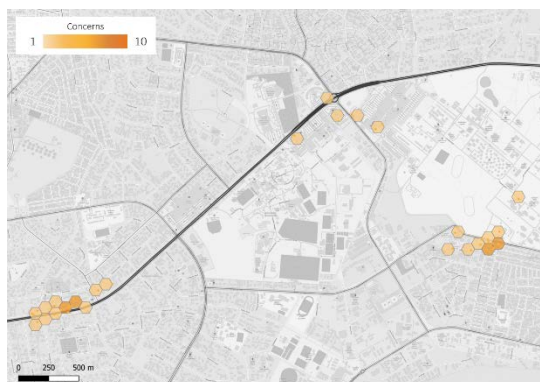
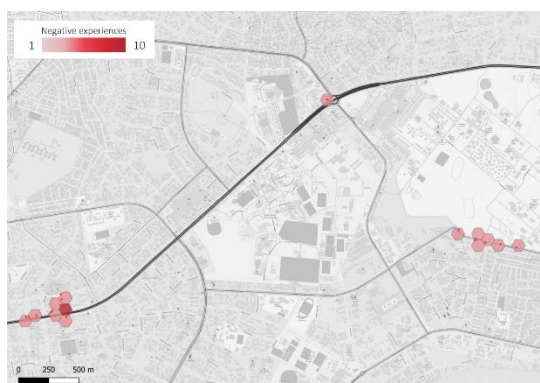
Figure 27. Main walkability outcomes in Great East Road.

In Great East Rd., most of the walking experiences were positive (49.7%) and related to 'Safe crossing' (14.4%), 'Presence of footpath' (13.8%) and 'Lighting, seating or ramps' (6.9%). Followed by concerns (35.4%) related to 'Unsafe crossing' (10.2%), 'Speed of traffic' (9.4%) and 'Fear of crime' (1.9%). And finally, negative experiences (15%), related to 'Unsafe crossing' (4.4%), 'Speed of traffic' (3.6%) and 'Fear of crime' (3%).

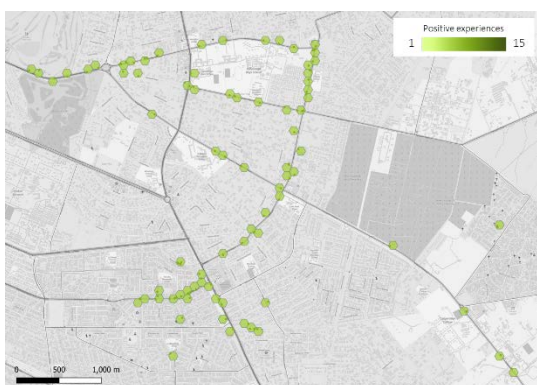
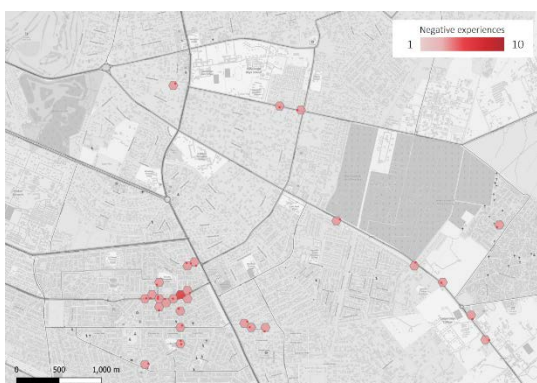
Figure 30. Main walkability outcomes in Leopards Hill Road.

In Leopards Hill Rd., most of the walking experiences were concerns (48%) and related to 'Poor drainage or protection from weather' (8.6%), 'No lighting, seating or ramps' (7.9%) and 'insufficient space or poor path quality' (4.1%). Followed by positive experiences (39.2%) related to 'Sufficient space' (6.5%), 'Lighting, seating or ramps' (5.2%) and 'Safe crossing' (4.9%). And finally, negative experiences (12.8%), related to 'Poor drainage or protection from weather' (2.1%), 'No footpath' (1.7%) and 'No lighting, seating or ramps' (1.6%).

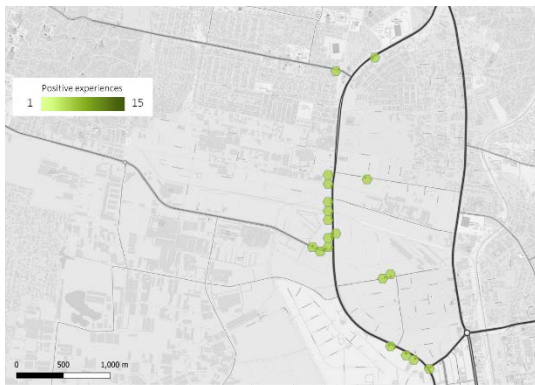
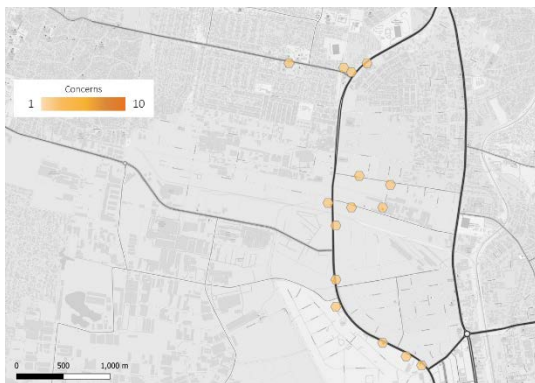
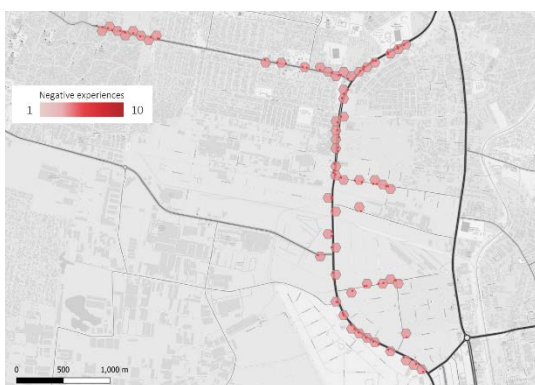
Figure 33. Main walkability outcomes in Lumumba Road.

In Lumumba Rd., most of the walking experiences were negative (67.2%) and related to 'Insufficient space or poor path quality' (2.4%), 'Unsafe crossing' (2.4%) and 'Fear of crime' (1.7%). Followed by positive experiences (20%) related to 'Sufficient space' (3.8%), 'Lighting, seating or ramps' (2.4%) and 'Safe crossing' (1.7%).. And finally, concerns (12.8%), related to 'Insufficient space or poor path quality' (2.4%), 'Unsafe crossing' (2.4%) and 'Fear of crime' (2.4%).

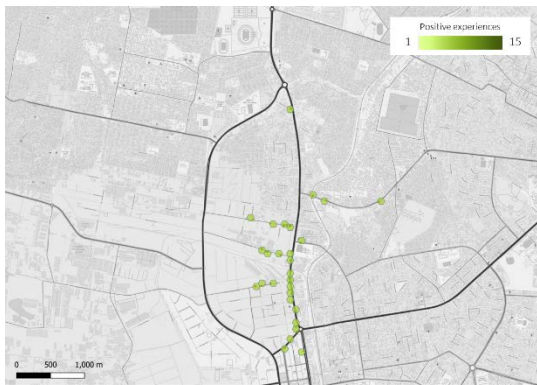
Figure 36. Main walkability outcomes in Great North Road.

In Great North Rd., most of the walking experiences were negative (58.6%) and related to 'Speed of traffic' (11.6%), 'Unsafe crossing' (10.4%) and 'insufficient space or poor path quality' (9.9%). Followed by positive experiences (22.3%) related to 'Secure' (3%), 'Sufficient space' (3%) and 'Lighting, seating or ramps' (2.3%). And finally, concerns (19.1%), related to 'Driver behaviour' (1.5%), 'Poor drainage or protection from weather' (1.5%) and 'Unsafe crossing' (1.5%).

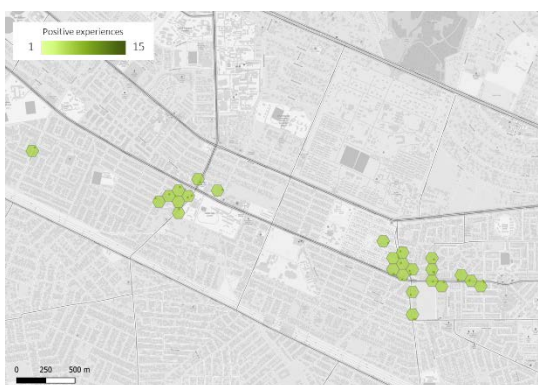
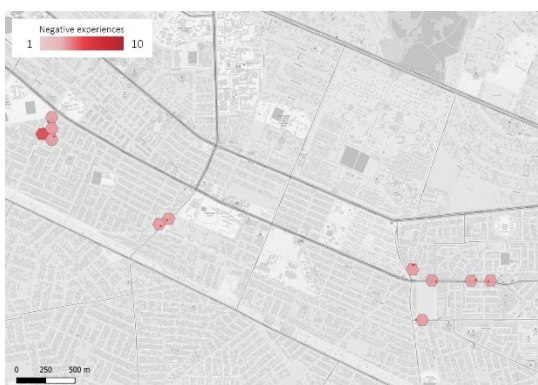
Figure 39. Main walkability outcomes in Chilimbulu Road.

In Chilimbulu Rd., most of the walking experiences were positive (46.4%) and related to 'Clean and peaceful' (9.5%), 'Lighting, seating or ramps' (9.5%) and 'Designed for people'(8.5%). Followed by concerns (33.3%) related to 'Poor drainage or protection from weather' (4.7%), 'Fear of crime' (2.8%) and 'No lighting, seating or ramps' (2.8%) . And finally, negative experiences (20.3%), related to 'No lighting, seating or ramps' (3.3%), 'Poor drainage or protection from weather' (3.3%) and 'Speed of traffic' (3.3%).

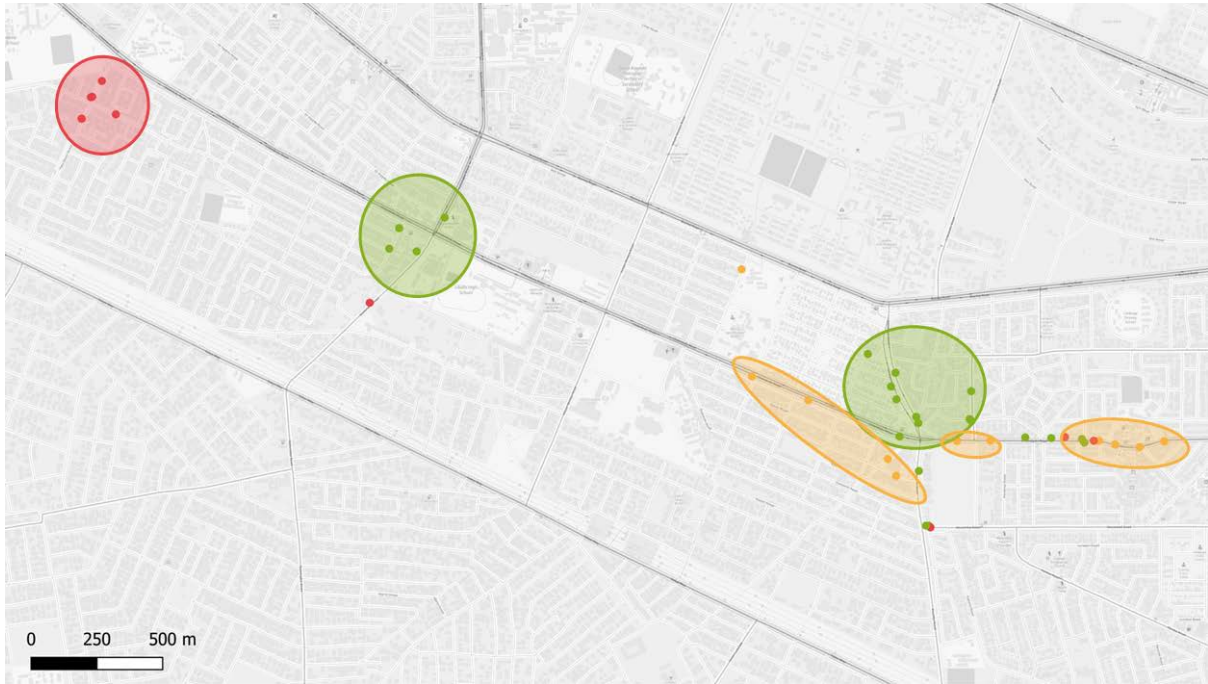
Assess place with positive experiences related to ‘Drainage and protection from weather’ and ‘Lighting, seating or ramps’ (for best practices) and negative experiences and concerns related to ‘Poor drainage and protection from weather’ and ‘Poor lighting, seating or ramps’ (for future interventions).

Figure 41. areas for proposed intervention in Great North Rd.

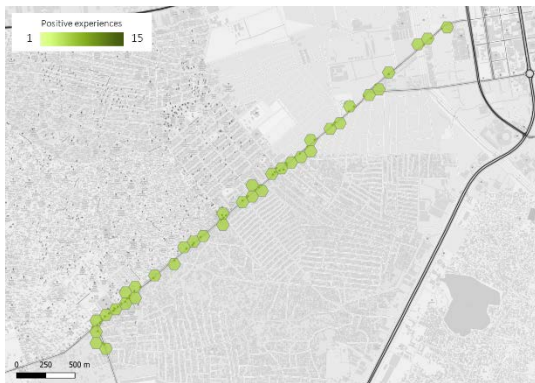
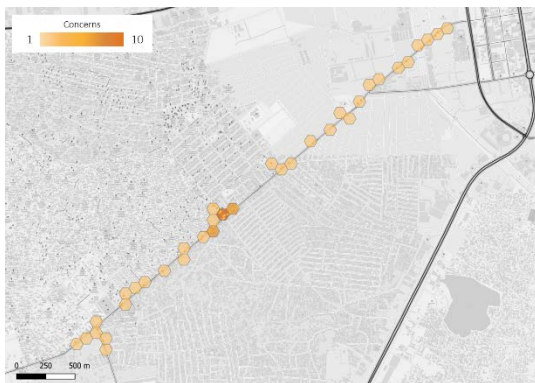
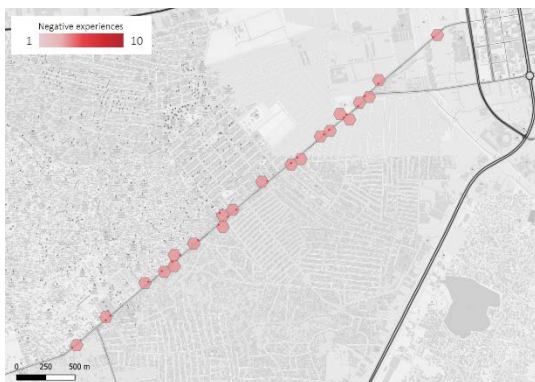
Figure 42. Main walkability outcomes in Los Angeles Road.

In Los Angeles Rd., most of the walking experiences were concerns (45.4%) and related to 'Driver behaviour' (6.6%), 'Poor drainage or protection from weather' (6.6%) and 'Unsafe crossing' (6%). Followed by positive experiences (37.4%) related to 'Secure' (5.2%), 'Lighting, seating or ramps' (4.8%) and 'Clean air and peaceful' (4.7%). And finally, negative experiences (17.2%), related to 'Driver behaviour' (2.5%), 'Poor drainage or protection from weather' (2.3%) and 'Unsafe crossing' (2.1%).

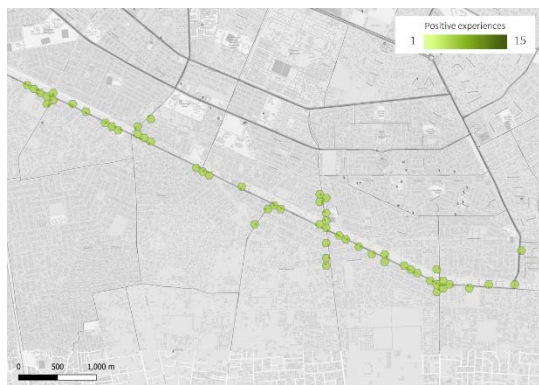
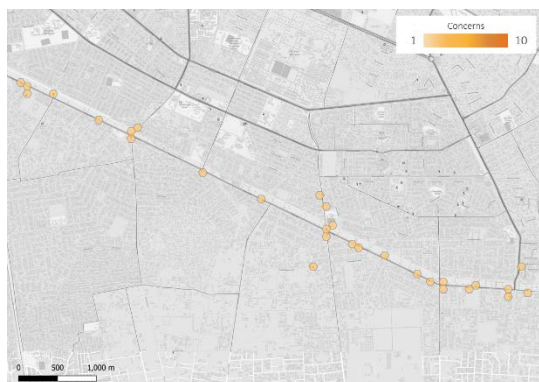
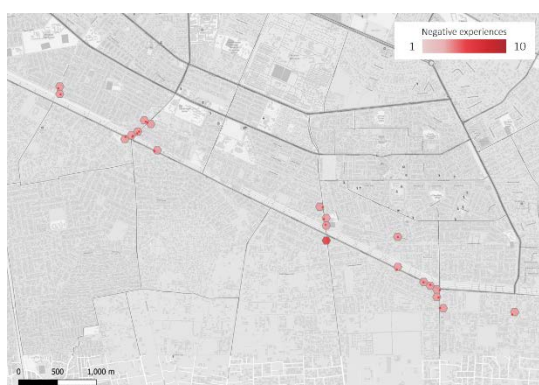
Figure 45. Main walkability outcomes in Tokyo Road.

In Tokyo Rd., most of the walking experiences were positive (55.1%) and related to 'Secure' (7.3%), 'Safe crossing' (7%) and 'Sufficient space' (7%). Followed by concerns (25.7%) related to 'Poor drainage or protection from weather' (3.4%), 'No lighting, seating or ramps' (2.2%) and 'Unsafe crossing' (2.2%). And finally, negative experiences (19.1%), related to 'No footpath' (2.5%), 'No lighting, seating or ramps' (2.3%) and 'Insufficient space or poor path quality' (2%).

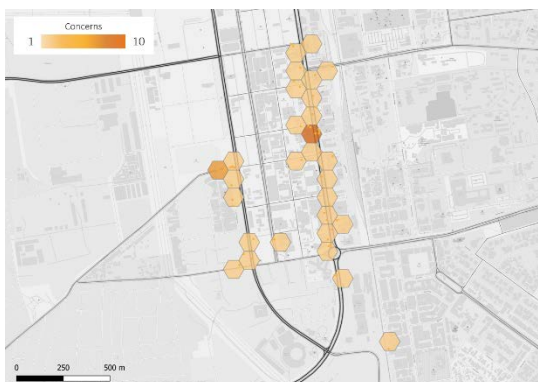
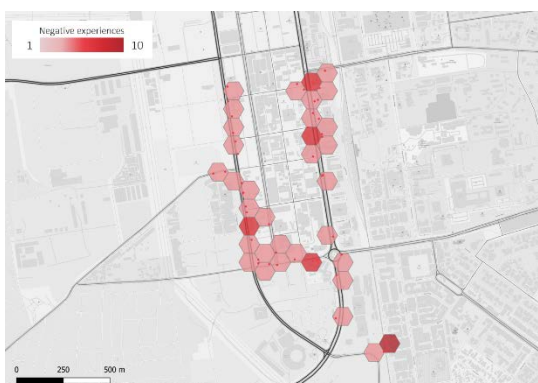
Figure 48. Main walkability outcomes in Cairo Road.

In Cairo Rd., most of the walking experiences were negative (43.2%) and related to 'Poor drainage or protection from weather' (8%), 'Fear of crime' (5%) and 'Driver behaviour' (3.4%). Followed by concerns (41.7%) related to 'Poor drainage or protection from weather' (10.2%), 'Fear of crime' (6.8%) and 'Dirty, noisy or poor air quality' (4.6%) . And finally, positive experiences (15.2%), related to 'Safe crossing' (5%), 'Designed for people' (4.3%) and 'Presence of footpath' (3.4%).

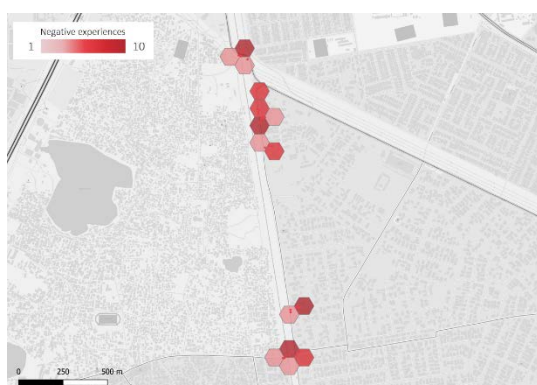
Figure 51. Main walkability outcomes in Railway Corridor.

In Railway corridor, most of the walking experiences were negative (50.4%) and related to 'Driver behaviour' (7.4%), 'Speed of traffic' (7.2%) and 'Unsafe crossing' (7%). Followed by positive experiences (41%) related to 'Supported and directed' (8.2%), 'Appropriated traffic speed' (6.2%) and 'Safe crossing' (5.5%) . And finally, concerns (8.5%), related to 'Fear of crime' (1.8%), 'No lighting, seating or ramps' (1.4%) and 'Harassment' (1.2%).

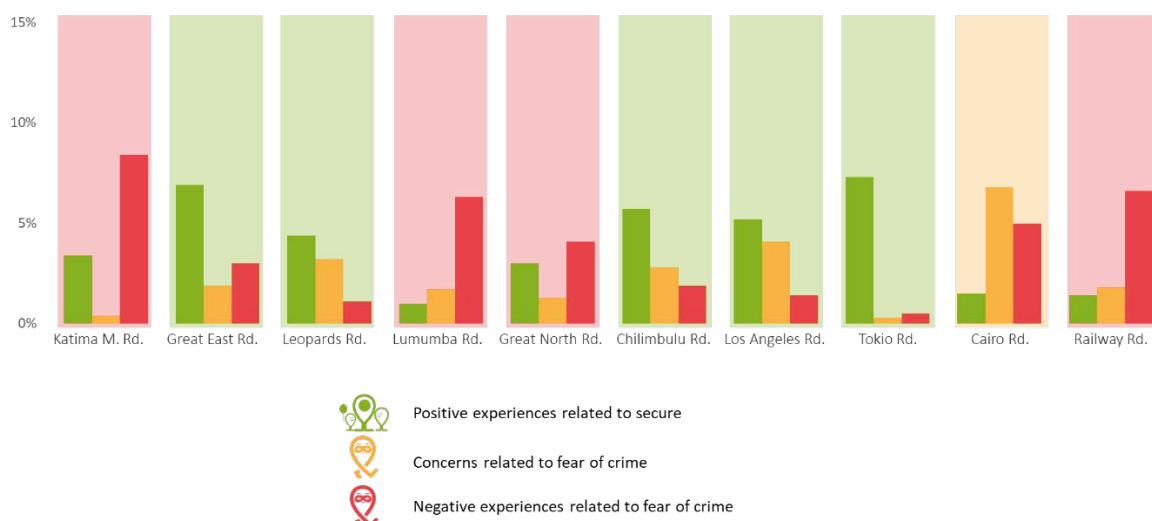
Places to learn from	Tokyo Rd., Great East Rd., Chilimbulu Rd., Los Angeles Rd., Leopards Hill Rd.
Places to improve	Katima Mulilo Rd., Railway Corridor, Lumumba Rd., Great North Rd., Cairo Rd.

Figure 58. Walking experiences related to personal security by study area.

Personal security, either fear of crime or feeling secure, was the fifth most frequent determinant (10%) related to walking experiences in Lusaka, with 4.3% of observations on secure related to positive experiences, while 3.1% and 2.6% of observations on fear of crime related to negative experiences and concerns respectively. By study area, there were five places with more positive experience related to secure: Tokyo Rd. (7.3%), Great East Rd. (6.9%), Chilimbulu Rd. (5.7%), Los Angeles Rd. (5.2%), and Leopards Hill Rd. (4.4%). There was one place with more concerns: Cairo Rd. (6.8%), although it also had a considerable number of negative experiences (5%). Finally, there were four places with more negative experiences: Katima Mulilo Rd. (8.4%), Railway Corridor (6.6%), Lumumba Rd. (6.3%), and Great North Rd. (4.1%).

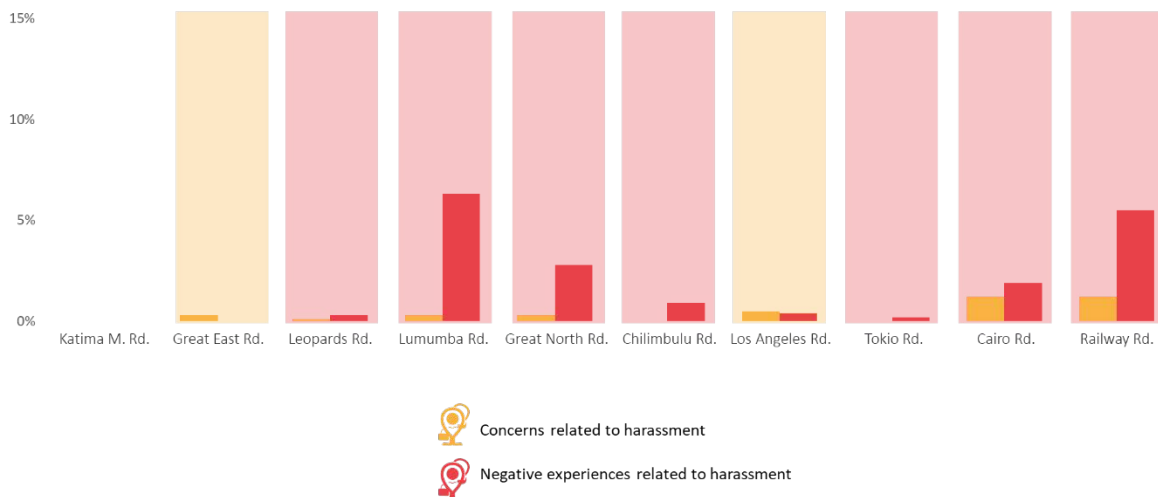
Places to learn from	Katima Mulilo Rd., Great East Rd., Los Angeles Rd., Tokyo Rd.
Places to improve	Lumumba Rd., Railway Corridor, Great North Rd., Cairo Rd.

Figure 65. Walking experiences related to harassment by study area.

Harassment is the twelfth and least frequent determinant (2%) related to negative experiences (1.6%) and concerns (0.4%) in Lusaka, , since the Walkability App does not include a determinant on no harassment related to positive experiences. By study areas, there were seven places with more negative experiences: Lumumba Rd. (6.3%), Railway Corridor (5.5%), Great North Rd. (2.8%), Cairo Rd. (1.9%), Chilimbulu Rd. (0.9%), Leopard Hills Rd. (0.3%), and Tokyo Rd. (0.2%). There were two places with more concerns: Los Angeles Rd. (0.5%) and Great East Rd. (0.3%). Finally, there was one place with no observations related to harassment: Katima Mulilo Rd.

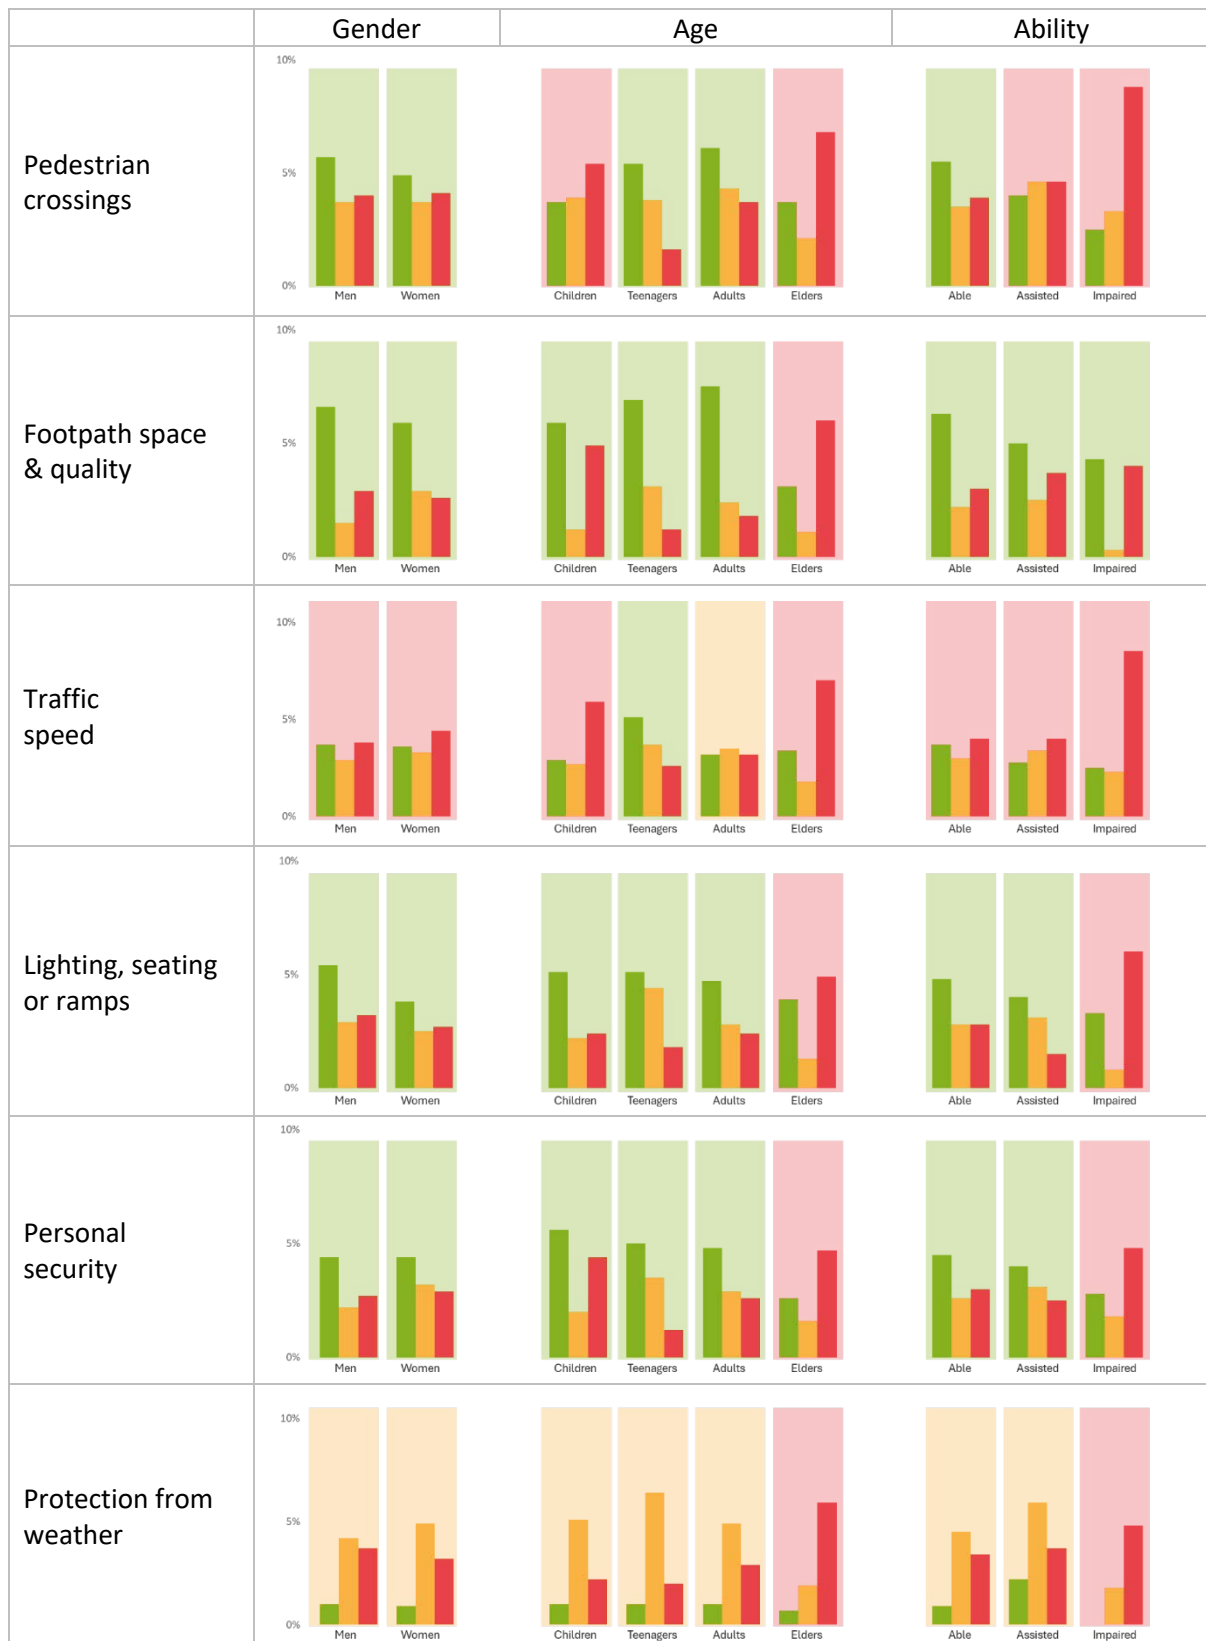
Table 15. Percentage of walking experience related to each environmental determinant by pedestrian profile (1/2).

The following tables 15 and 16 present a summary of more detailed graphs, with the percentage of observations on all environmental determinants related to different experiences, by pedestrian profile: age, gender and ability.

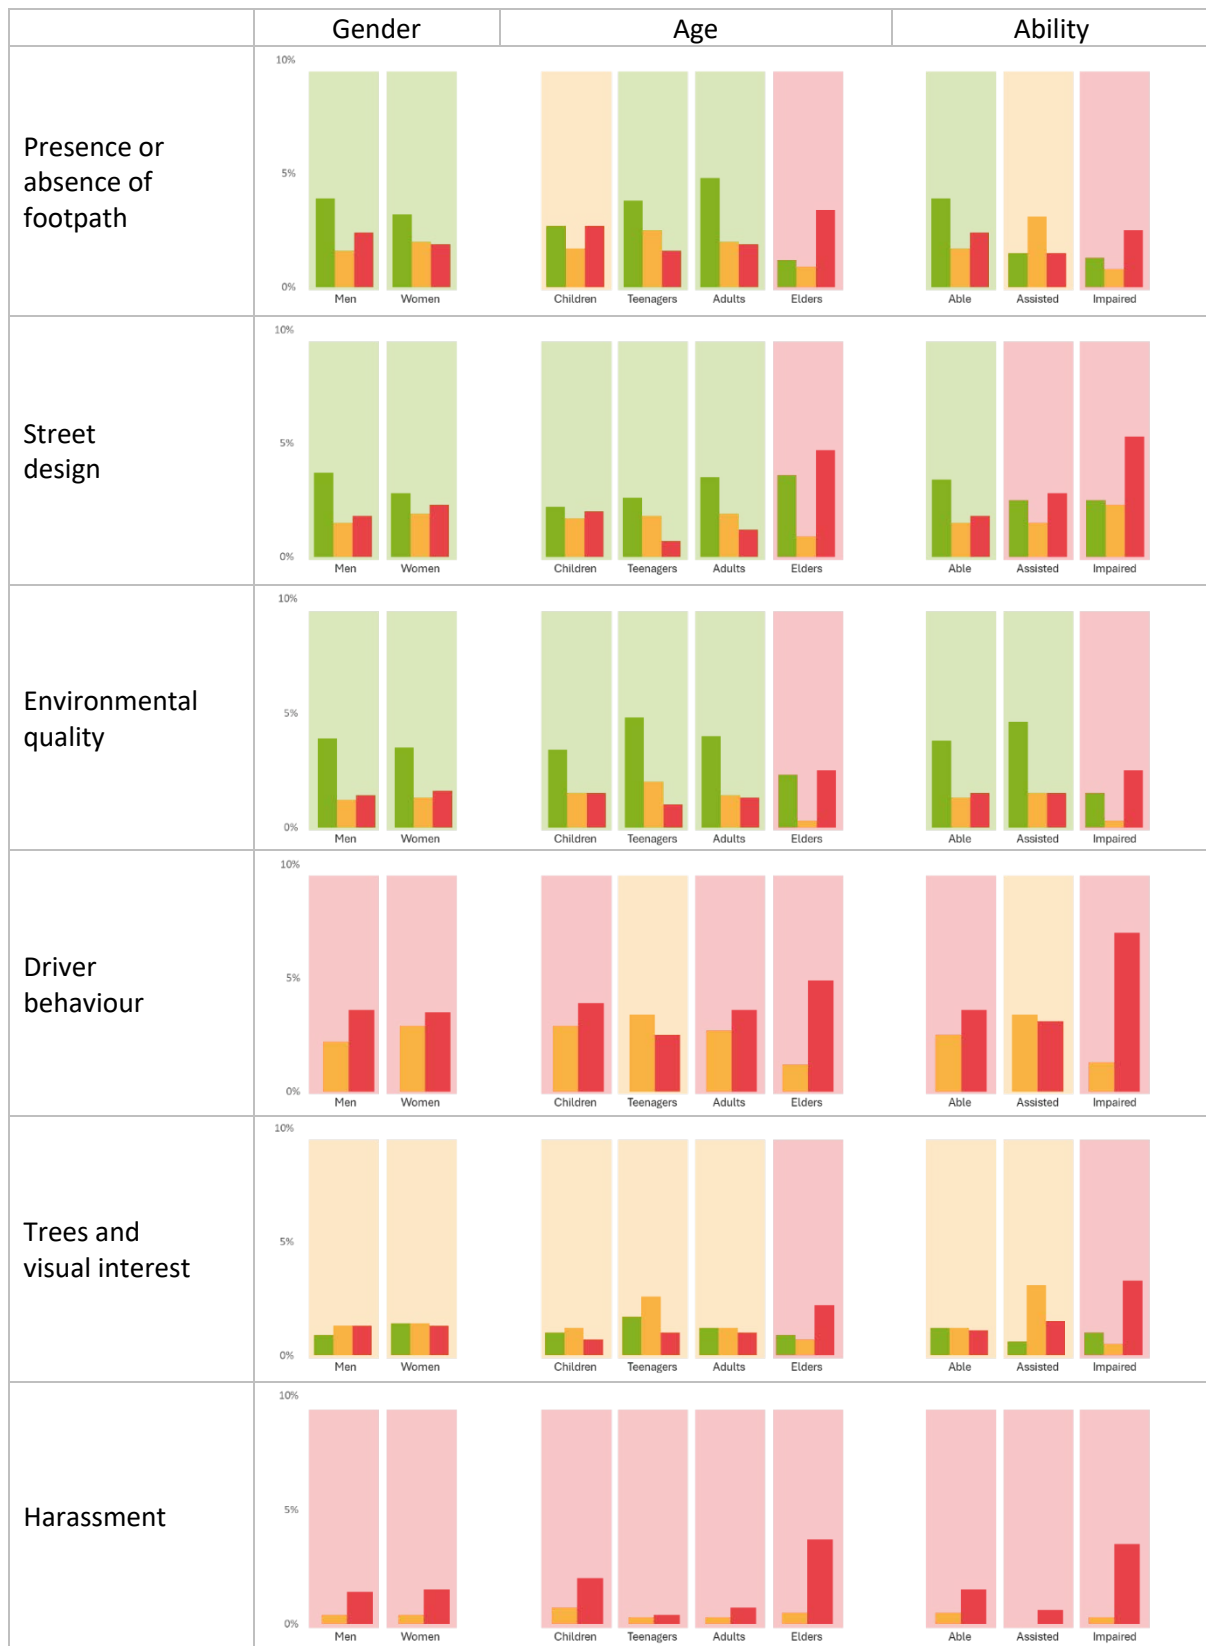
Table 16. Percentage of walking experience related to each environmental determinant by pedestrian profile (2/2).
